**POTENTIAL HAZARDOUS WASTE SITE
PRELIMINARY ASSESSMENT
PART 1 - SITE INFORMATION AND ASSESSMENT**

01 SITE NAME (Legal, common, or descriptive name of site) Babylon Landfill		02 STREET, ROUTE NO., OR SPECIFIC LOCATION IDENTIFIER Edison Ave.			
03 CITY Babylon	04 STATE NY	05 ZIP CODE 11702	06 COUNTY Suffolk	07 COUNTY CODE 103	08 CONG DIST 02
09 COORDINATES LATITUDE 40° 43' 33.5" W		LONGITUDE 073° 22' 40.0"N

EXECUTIVE SUMMARY

POTENTIAL HAZARDOUS WASTE SITE
SITE INSPECTION REPORT
PART 1 - SITE LOCATION AND INSPECTION INFORMATION

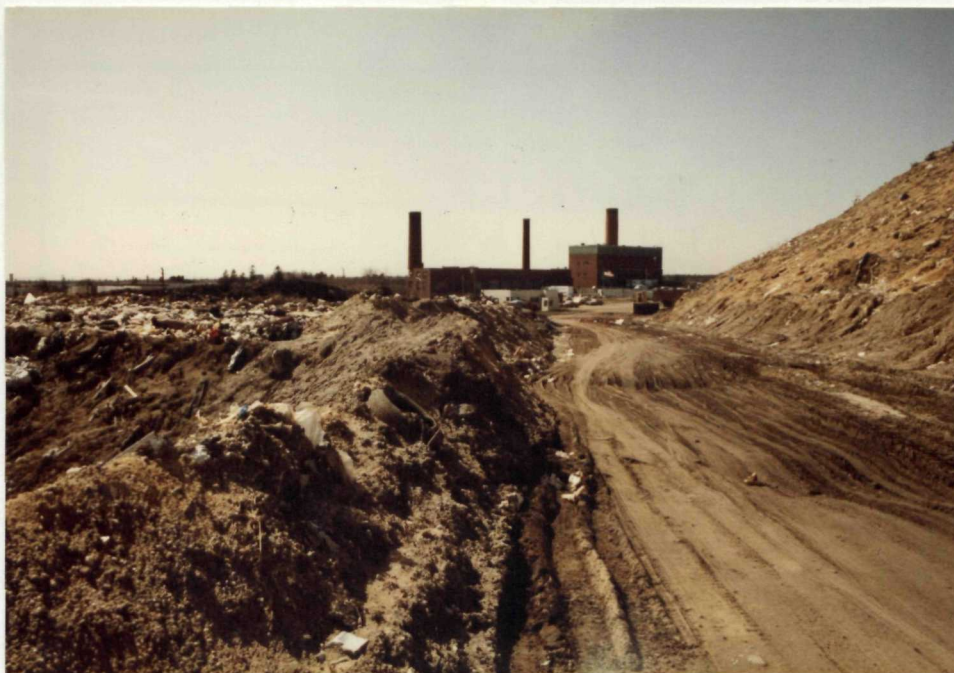
1. View west from access road of inactive incinerator buildings.

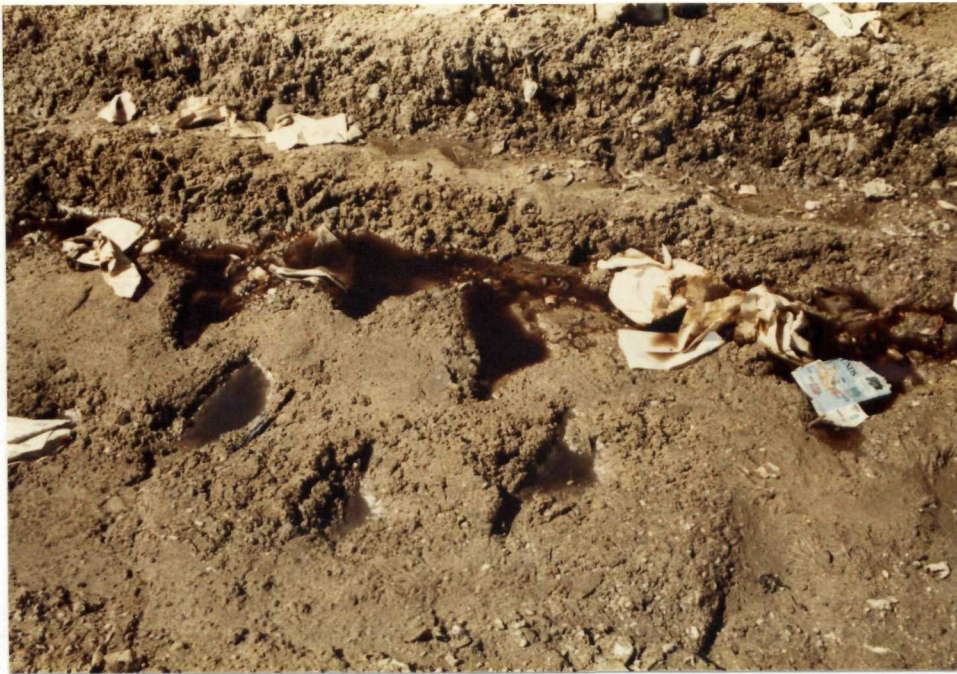
The entire site has been extensively filled. Leachate seeps were observed at the base of the fill.

3. Leachate seep along northern base of fill.

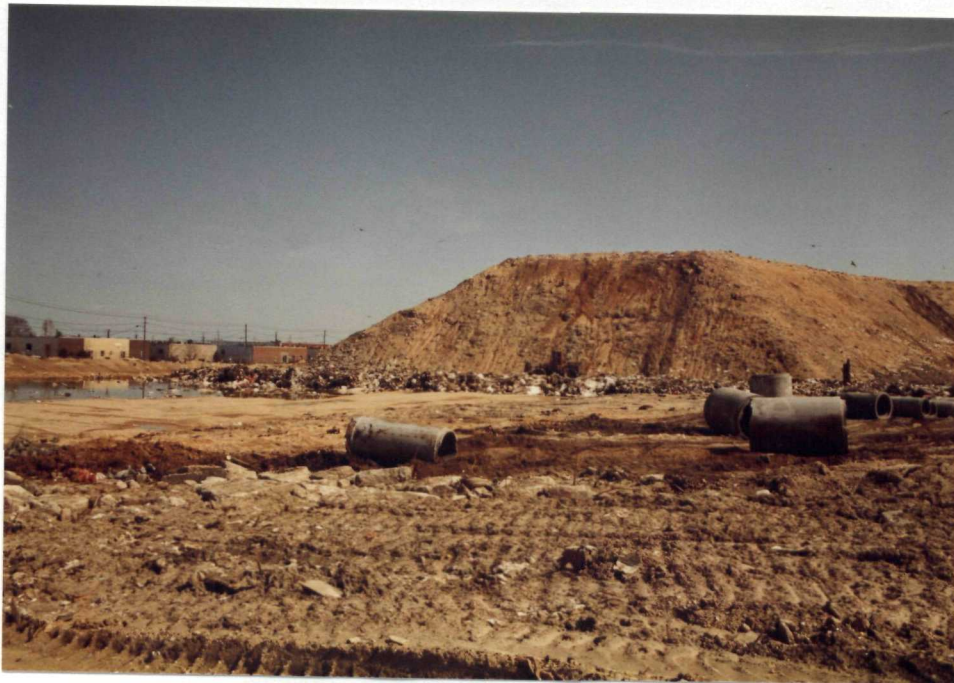
Prior to the opening of the Southwest Sewer District in 1981, the landfill received septic wastes from scavengers serving residential, commercial and industrial clients.

4. View east of former septic lagoon area.

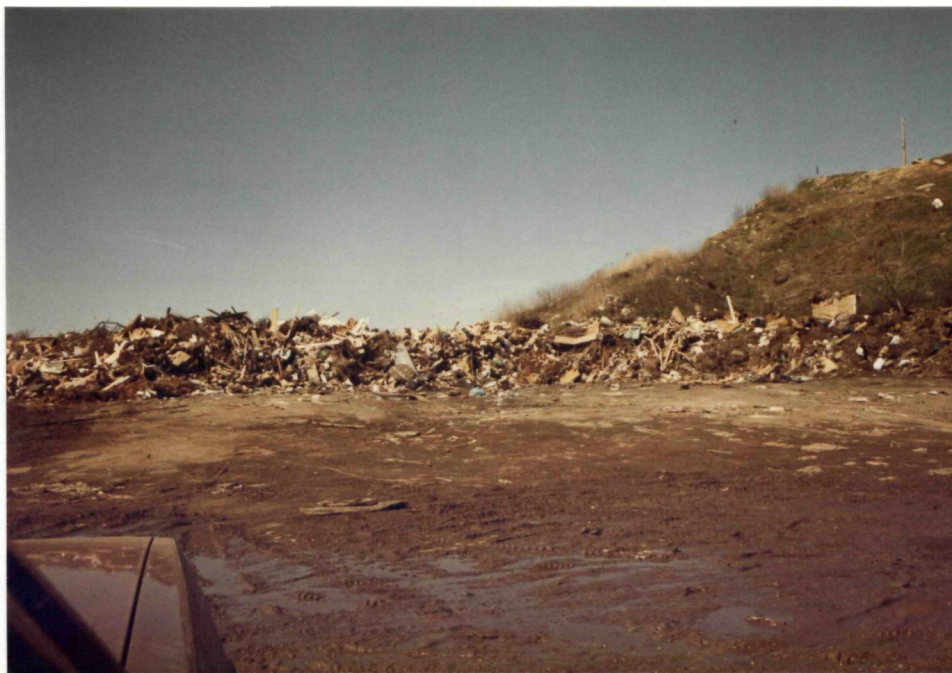
Improper daily cover procedures result in exposure of refuse, numerous leachate seeps and refuse being blown about the site.

5. View north of edge of active work cell.

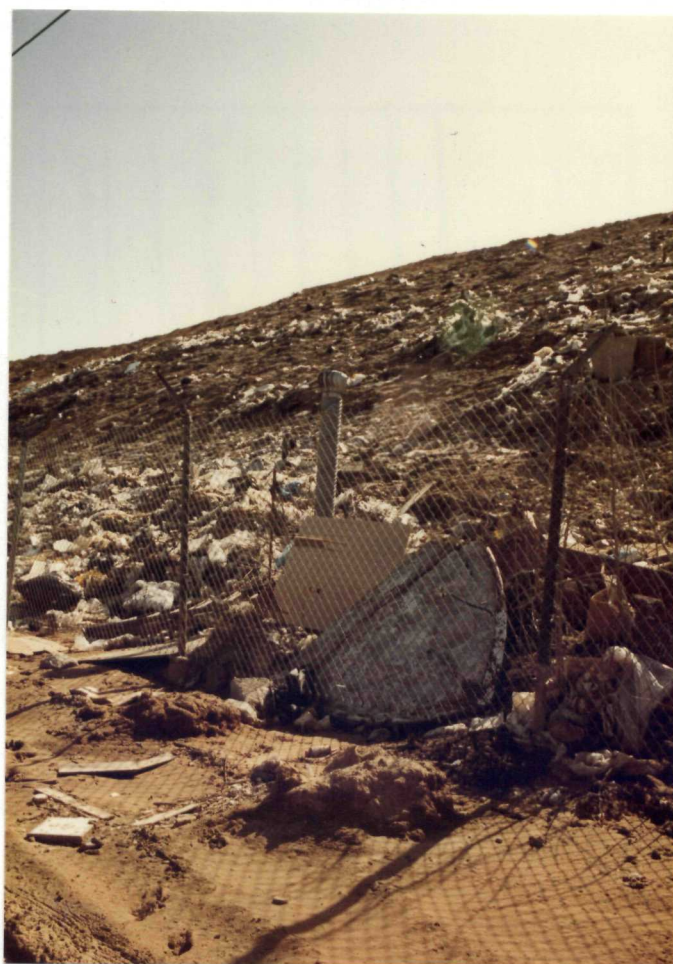
Methane generation from the landfill has resulted in local air quality problems.

6. Methane venting chimney on east edge of site.

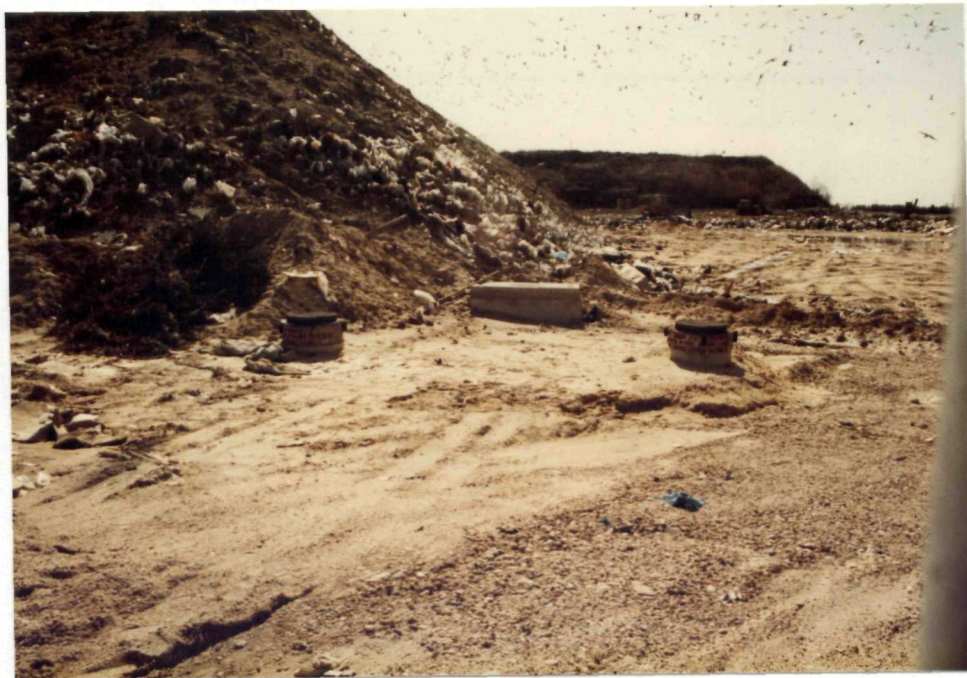
7. View west of leachate collection sump at the northwest corner of the site.
